# Advanced Gas Turbine

## Technology Project

### Sixth Semiannual Report

For work performed from 1 July 1982 - 31 December 1982

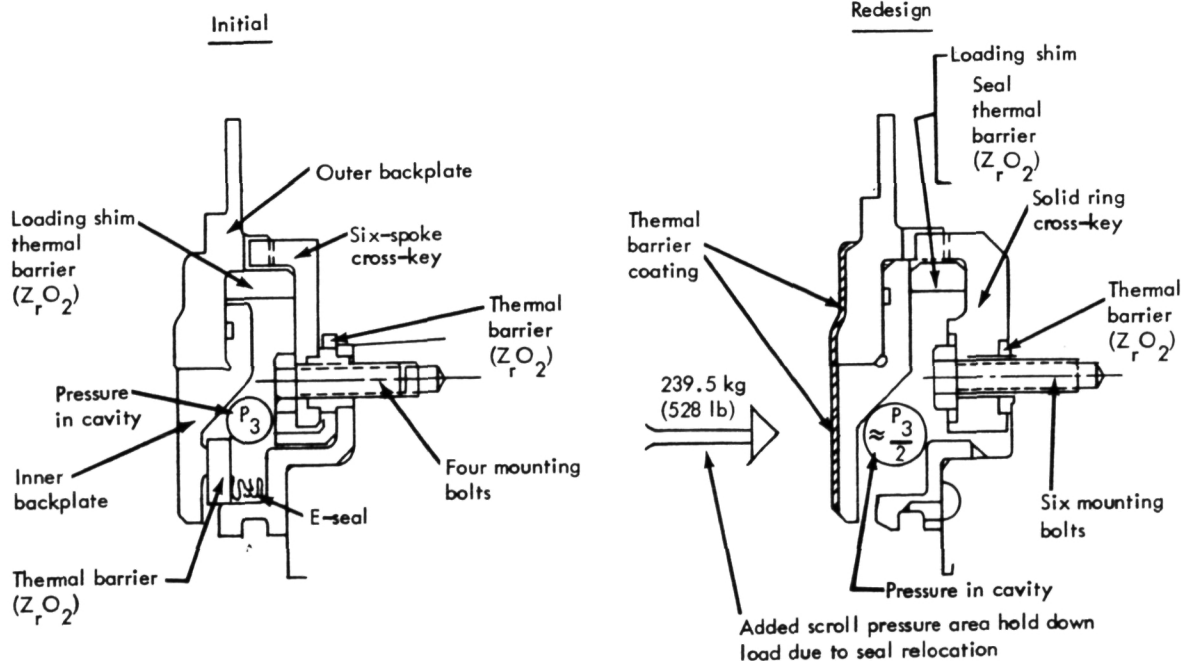
TE83-1981

### Redesign

Figure 16. Scroll mounting system comparison—present versus redesign.

A layout was started that not only addresses the transient thermal deflection problem but also the scroll hold down problem for both metal and ceramic scrolls. A sketch of the present and redesigned gasifier scroll support system is shown in Figure 16. The salient features of the redesign are listed in Table III. The gasifier turbine scroll support system that will be incorporated into engine BU6 (see Figure 17) is being redesigned.

Feature	Benefit
1. Seal relocated outboard	1. Reduces pressure behind inner backplate and increases pressure area force holding the scroll against the cross-key support
2. Solid ring cross-key support	2. Increases stiffness, which reduces deflection under load
3. Increased number of support mounting bolts	3. Uniform distribution of load from scroll cross-key support into gasifier turbine bearing support
4. Increased inner backplate o.d. to be in load path between outer backplate and shim	4. No translation of inner backplate due to transient thermal deflection coning of outer backplate and scroll
5. Thermal barrier coating on scroll and outer backplate flow-path surfaces	5. Reduces transient thermal deflection, which allows reduced running clearances, resulting in improved efficiency

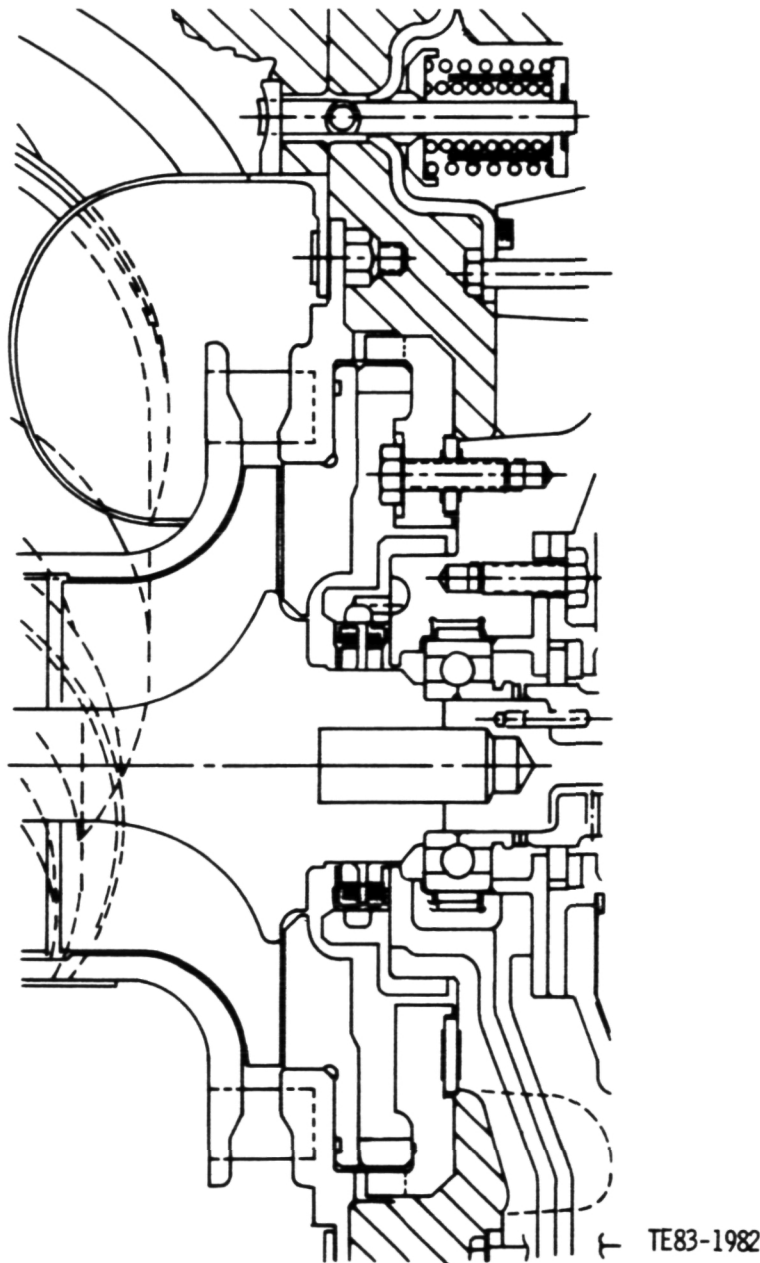
**Figure 17. Gasifier turbine—redesign scroll support system.**

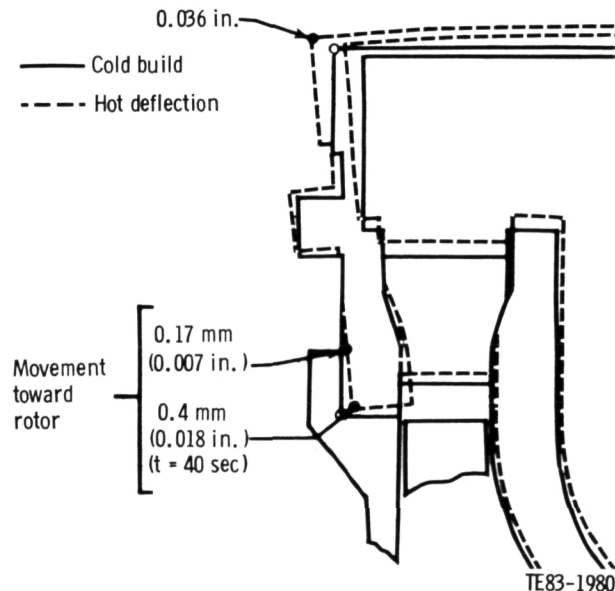
TE83-1980

Since the power turbine inner backplate analysis done prior to this test indicated a very minimal amount of coning (0.1 mm [0.004 in.]), which did not explain the rub, and the rub pin measurements indicated the backplate translated, the transient heat transfer and deflection analysis was extended to the power turbine scroll assembly. The results showed coning of the outer backplate, which caused the inner backplate to translate, as shown in Figure 19. The sum of deflection due to coning, translation due to outer backplate coning, and thermal growth of support structure was sufficient to use up the build clearance

Figure 19. Power turbine scroll assembly—transient deflection.

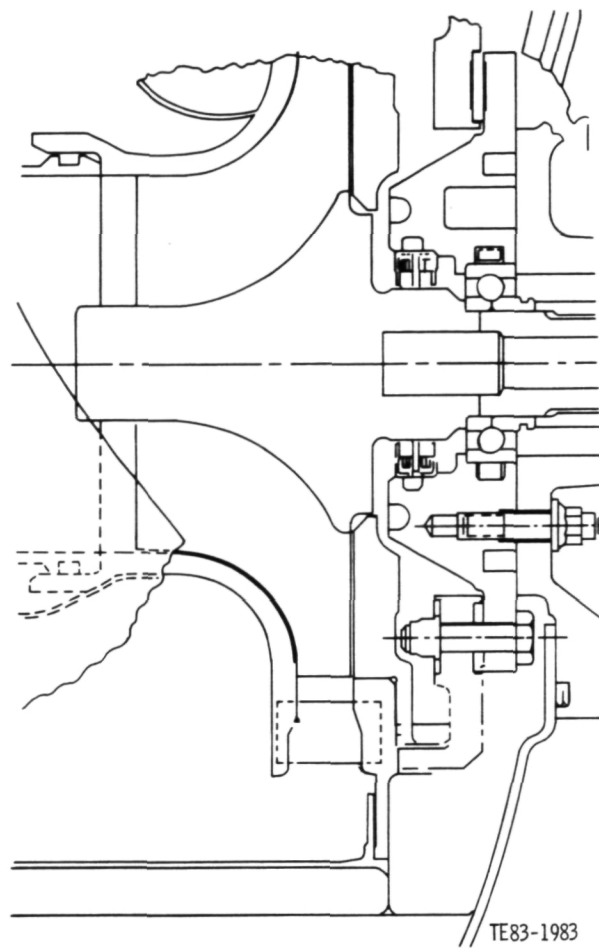
Figure 20. Power turbine—redesign scroll support system.

The power turbine scroll support system design that will be incorporated into engine BU6 (see Figure 20) is being developed.

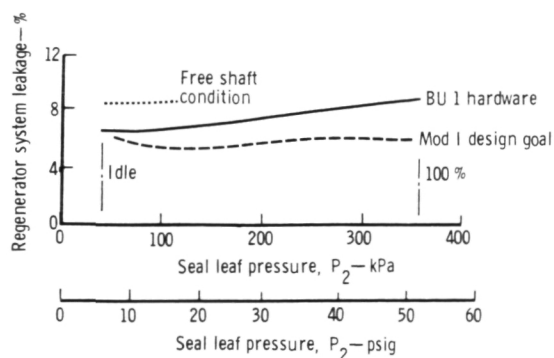
TE82-4320

The first sets of regenerator hardware exhibited system leakage levels, as shown in Figure 27, that were acceptable for initial engine testing, but too high for later engine performance evaluations. The objective of the analysis of system leakage characteristics was to identify and quantify the individual leakage sources to establish development goals for reducing system leakage.

Figure 27. Regenerator system leakage for BU1.

The immediate goal is to demonstrate system leakage levels approaching the Mod I goals (see Figure 27) with the seal and disk improvements to be tested during the next reporting period.

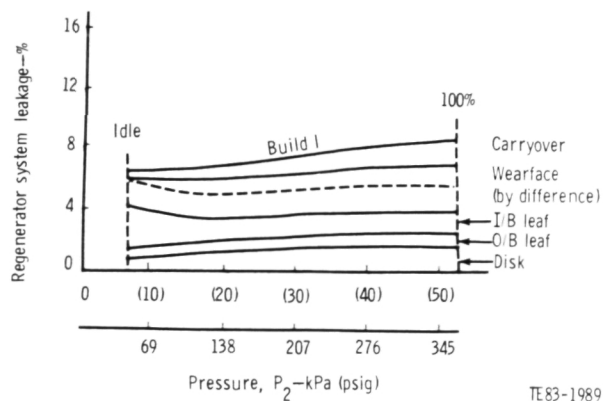
TE83-1989

Leakage was categorized into five areas—all of which could be based on analytical results and/or rig testing. Figure 28 illustrates the magnitude of these individual sources for the initial engine hardware set. Each is discussed in the following:

- **Outboard leaf.** Rig-measured leaf leakages are scaled to engine conditions. Observation of leaf operation shows that the majority of leakage occurs at leaf joints and corner leaf miters. Elimination or reduction of the number of joints is being pursued in reducing this leakage.

- **Disk.** Investigation of the physical characteristics of the initial AGT 100 code 9461 (CGW) aluminum silicate disks revealed abnormally high "through wall" leakage due to wall porosity. Comparable disks used in the Allison CATE program exhibited through wall leakage levels 60%-75% lower than the AGT 100

Figure 28. Breakdown of regenerator leakage losses for AGT 100 BU1.

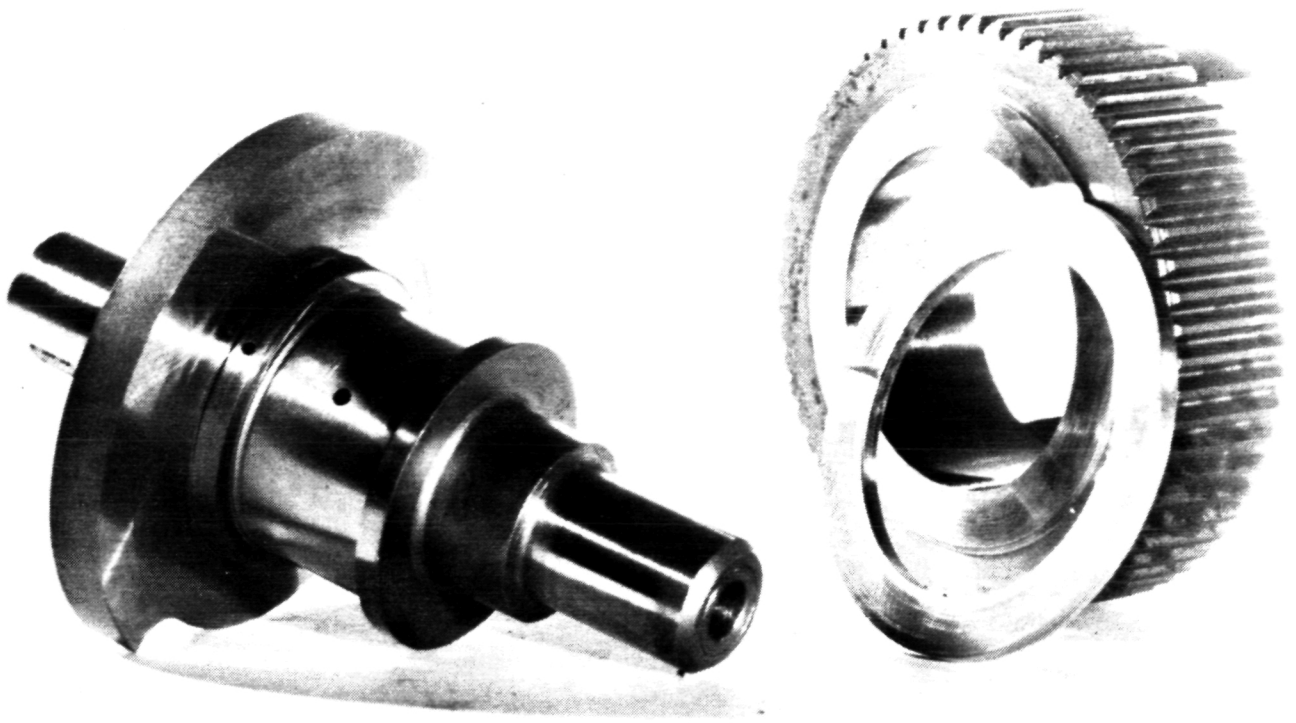
The next refinement included an oil dam in the shaft of the counterbalance. This allowed a layer of oil to build up in the shaft. A radial hole connected this passage to the interface area, allowing direct lubrication of contact surfaces. Also included were four radial oil slots in the face of the pinion. This modification produced improved endurance, but the surface wear of the contacting surfaces was still unsatisfactory for trouble-free engine use.

Figure 33. Regenerator drive counterbalance, thrust washer, and pinion.

The final modification included a leaded bronze thrust washer between the pinion and the counterbalance. This washer has two radial oil slots per side. The oil slots were eliminated from the face of the pinion. This unit underwent 7 hr of testing, including more than 5 hr at 75% and 100% load. The contact surfaces showed no signs of degradation. Figure 33 shows the counterbalance, thrust washer, and pinion after testing. Based on these results, it was determined that testing was completed and the drive unit was acceptable for engine use.

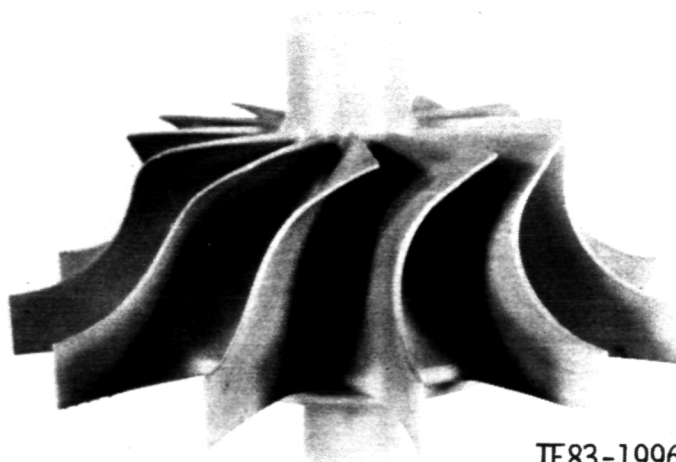
TE83-1996

Inspections of sintered GTE  $\text{Si}_3\text{N}_4$  rotors received this reporting period, which incorporated these processing modifications, revealed a greatly reduced incidence of the external and internal cracking. One of the most recent sintered rotors is shown in Figure 39. Future development activities will focus on additional optimization of the processing sequence. Concurrently, spin test characterization of rotors will be conducted.

Figure 39. GTE injection-molded sintered  $\text{Si}_3\text{N}_4$  gasifier turbine rotor.

**Sintering.** A modified sintering technique developed by GTE laboratories has significantly reduced cracking in sintered AGT gasifier rotors. This has raised the density of sintered crack-free rotors, theoretically, to as high as 97%.
